Corinthian Diagnostic Radiology

Leslie A. Saint-Louis M.D., neuroradiologist

Review of radiology studies: Cervical X-Ray 7/23/14, Cervical MRI 7/23/14, post-op cervical CT 7/13/15 and their reports.

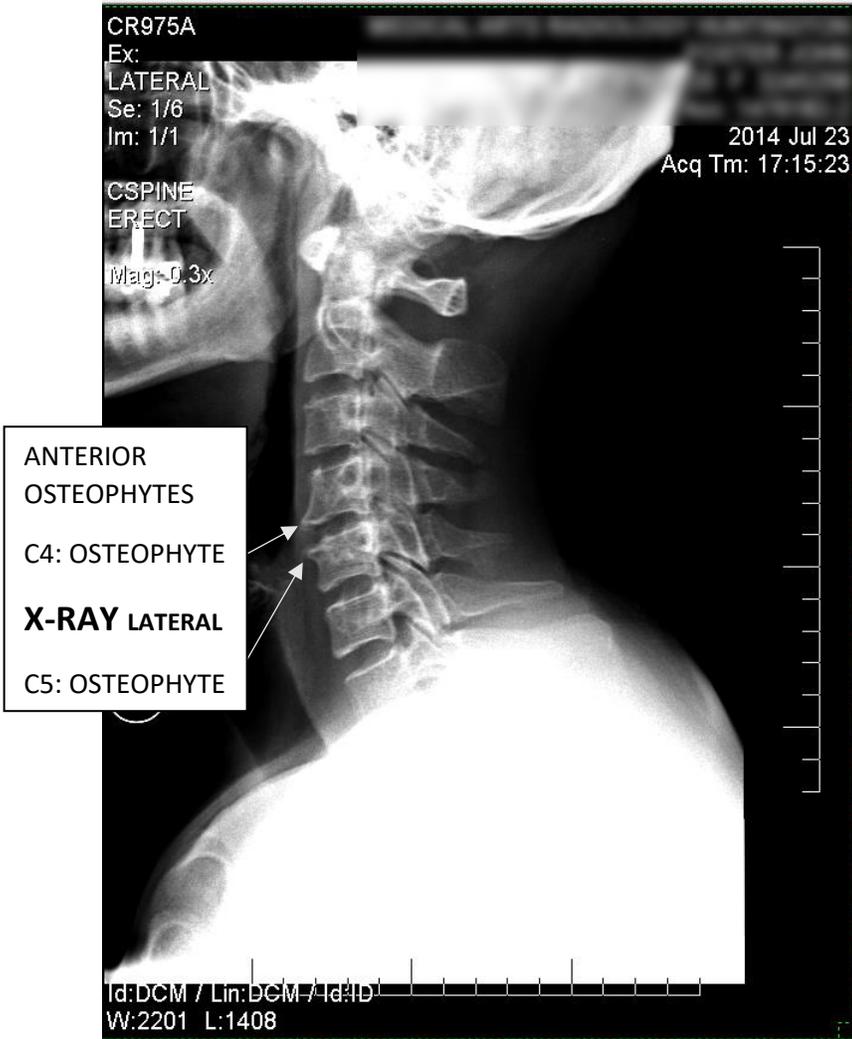
Figure 1

PRE-OP LATERAL X-RAY, July 23, 2014: the osteophyte, bone spur, is anterior at C4-5, there is no osteophyte at C5-6 either anteriorly, or more importantly, posteriorly.

1A. "foraminal disc\osteophyte" usually implies a doubt about whether what is seen on the MRI is an osteophyte or disc herniation. If a herniation, usually an old dried-out one. In the conclusion, Dr. [Name Removed] states "foraminal herniation with associated osteophyte." But there is no posterior or lateral osteophyte visible at C5-6 either in the X-ray or MRI of 7/23/14, figures 1, 3, 4 and 8, obtained prior to his surgery. There are osteophytes anteriorly at C4 and C5, figures 1 and 2. A posterior osteophyte would have been visible on both the lateral X-Ray and the MRI, figures 1, 3 and 8.

2A. The right C5-6 posterior herniation extending into the proximal foramen and compromising the right C6 nerve does not have an osteophyte either superior or inferior to the herniation. The osteophytes present on either study is the anterior bridging osteophytes at C4-5 and the very small posterior osteophytes at C2-3, figures 1 and 2.

“foraminal disc\osteophyte” usually indicates either\or, or both. “Degenerative changes” do describe an acute or subacute herniation but osteophytes, chronic disc dehydration, hypertrophy, etc. There is no posterior osteophyte visible at C5-6. There are osteophytes anteriorly at C4-5, figures 1 and 2.

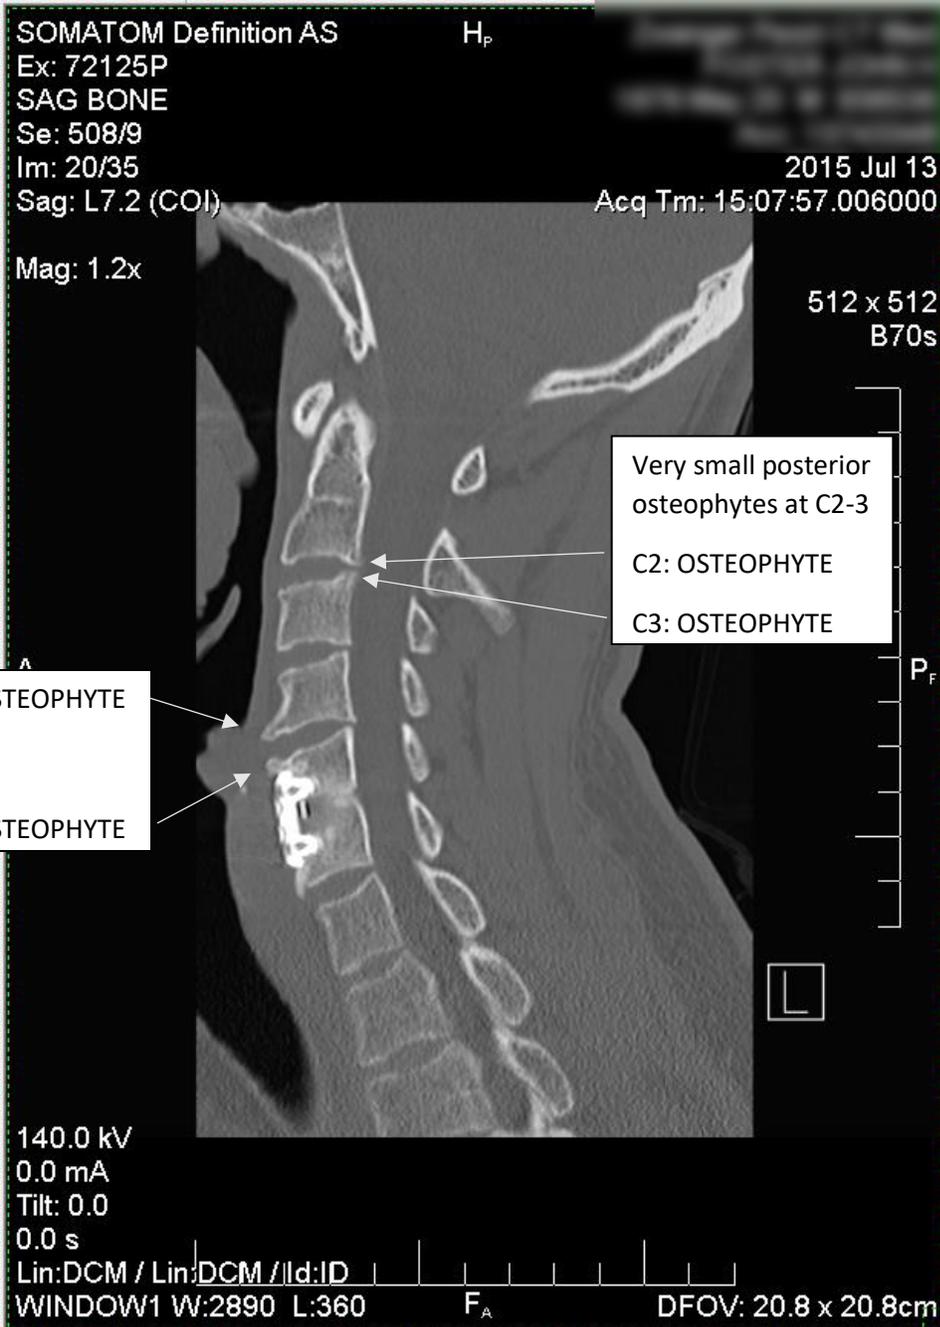
Figure 2

POST-OP (AFTER SURGERY) LATERAL REFORMATTED CT, July 13, 2015: CT sagittal view of the C4-5 anterior osteophyte. If there was a C5-6 posterior or lateral osteophyte (and there was not) it may or would have been resected at surgery, explaining why it would not be seen on this image.

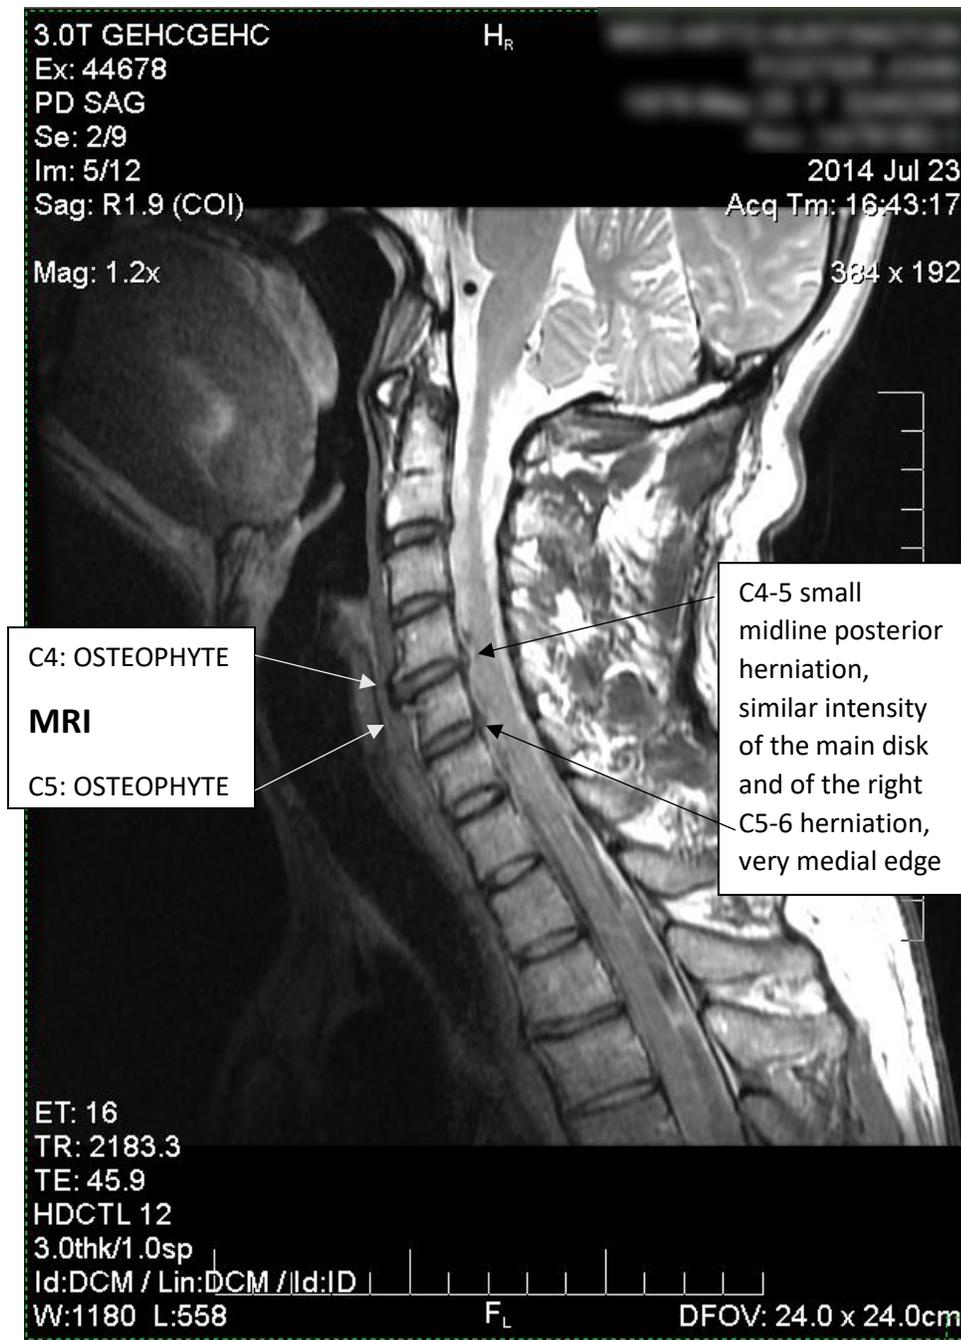
Figure 3

PRE-OP MRI LATERAL VIEW OF OSTEOPHYTE, July 23, 2014, same as the X-Ray: this is what a mature, chronic osteophyte on MRI looks like, it has marrow inside and dark cortical bone outside. Osteophytes at C4-5 are anterior. There are no osteophytes at C5-6 either anterior or posterior. The small posterior C4-5 herniation has the same intensity as the main disc and the right C5-6 herniation, black arrows, and in figure 8.

When disk material first herniates, it has a similar intensity to the normal disc on an MRI. As the disc considerably ages, it loses water and its intensity becomes darker on MRI than the normal looking disc, figure 9a. [Patient Name Removed] right C5-6 herniation has a similar intensity to the remaining disc material, figure 9b, between the vertebrae indicating that it is acute to subacute, not old, chronic. It takes many months to years for the disc to dry-out. This herniation at C5-6 is less than a few months old and similar in intensity to the small posterior midline herniation at C4-5, figures 3, 8-11.

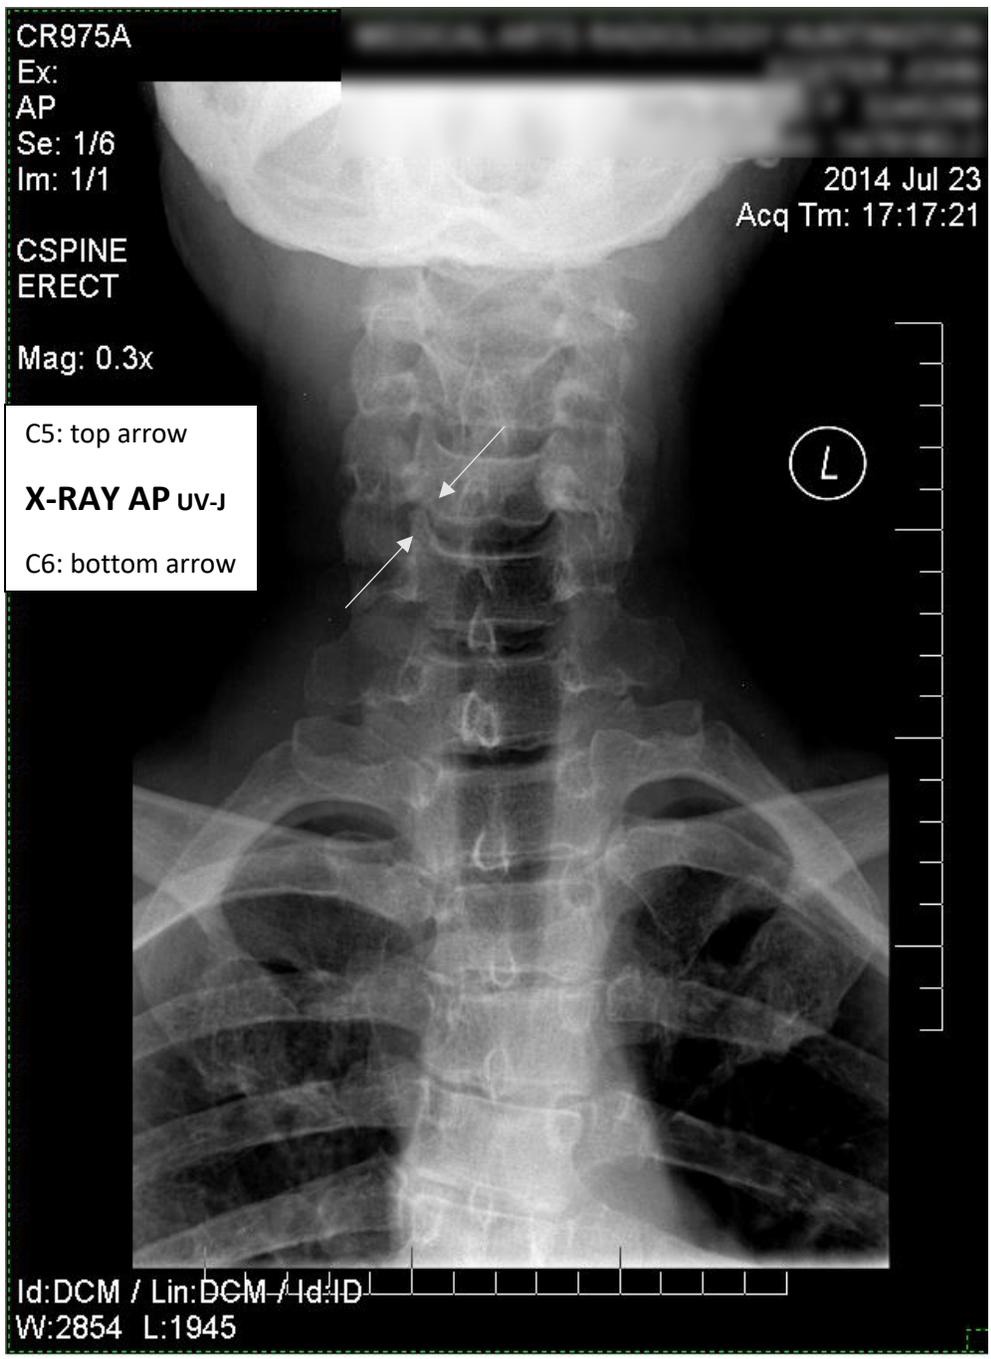
Figure 4

PRE-OP UNCOVERTEBRAL JOINT (UV-J) July 23, 2014, NORMAL: there are no osteophytes laterally at C5-6 at the uncovertebral joint. Uncus, (“unco”) means, “hook”.

The area depicted by the short arrow would suggest that there is bone thickening, an osteophyte, at the uncovertebral joint. But an osteophyte was not present at this location on the X-Ray, figure 4. Because the slice thickness of the image is 3mm it can include tissue from above or below it, called "volume averaging". In this case at C6, the bony cortex of the lateral mass/pedicle from below it, which is black. If the anatomy is slightly tilted, the image slice intersects anatomy below and "volume averaging" partially incorporates it onto the anatomy above and adds it to the normal uncovertebral joint thickness. This gives the false appearance of thickening, an osteophyte, of the uncovertebral joint. Even if this was an osteophyte, and it is not, it is lateral and in the mid to distal portion of the foramen and away from and not associated to the recent right posterior herniated disk. It is definitely not above or below the right C5-6 herniated disk fragment as indicated by Dr. [Name Removed] to "support the herniation".

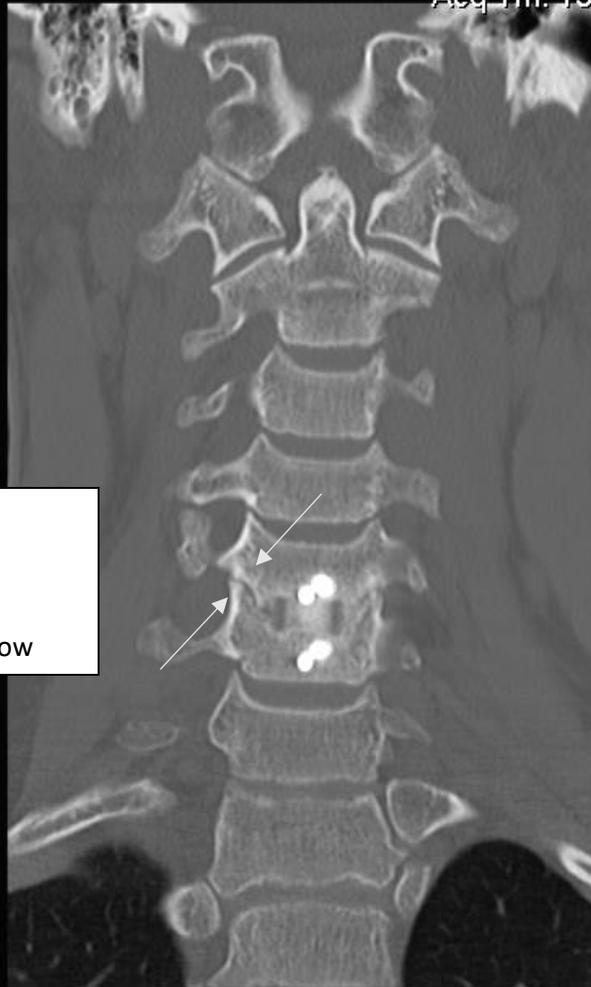
Figure 5

POST-P CT UNCOVERTEBRAL JOINT (UV-J) C5-6, July 13,2015, NOT NORMAL, SMALL RIGHT OSTEOPHYTES, ARROWS, SEE ALSO FIGURE 6, NOT PRESENT PRE-OP.

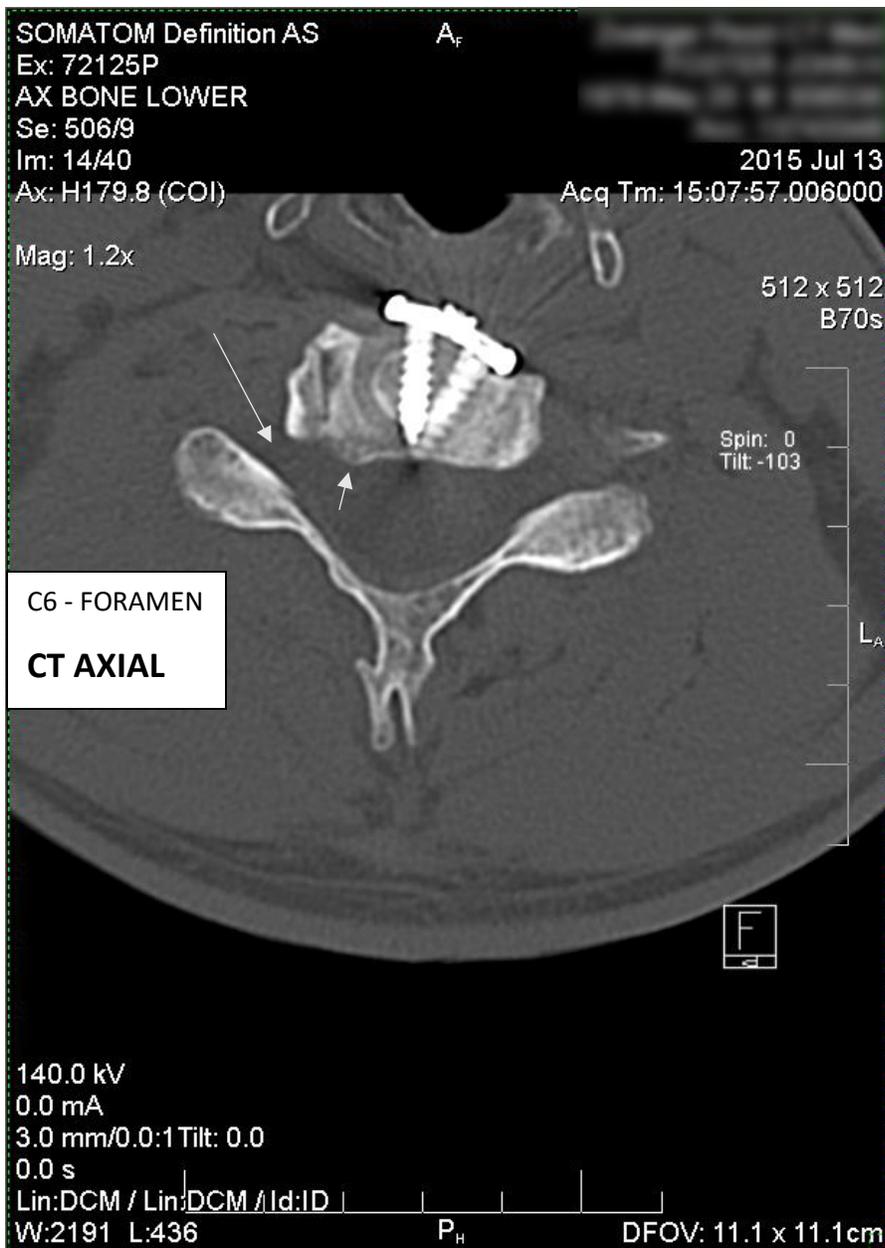
Figure 6

POST-OP AXIAL CT July 13, 2015: 1 year later, bony foramen (“window”) is clear, arrow. There is now a small and what “appears” to be an osteophyte right posterior C6, short arrow. It is just the remains of normal bone excavated during surgery and appearing to project posteriorly, see sagittal CT that follows, figure 7. This was not present on the pre-op July 23, 2014 X-Ray or MRI, figures 1 and 3.

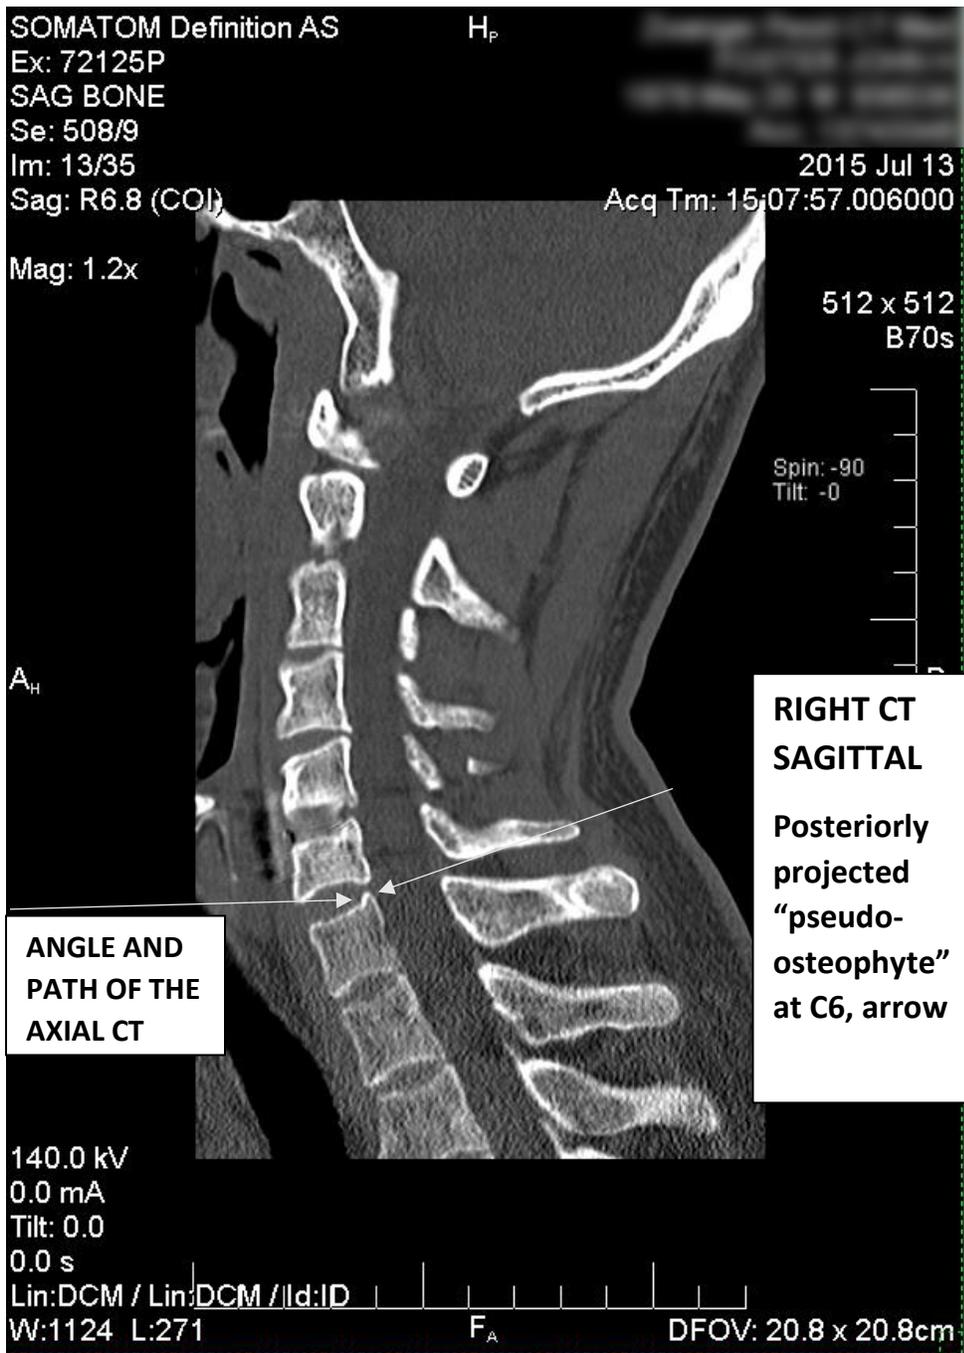
Figure 7

POST-OP CT SAGITTAL: it is this normal residual bone, arrow, after excavating part of the vertebra to make room for the fusion element, bone plug, between the C5 and C6 vertebra that seems to project beyond the vertebra posteriorly only because the axial slice orientation traverses the bone plug then it, arrow resulting in a false appearance of an osteophyte.

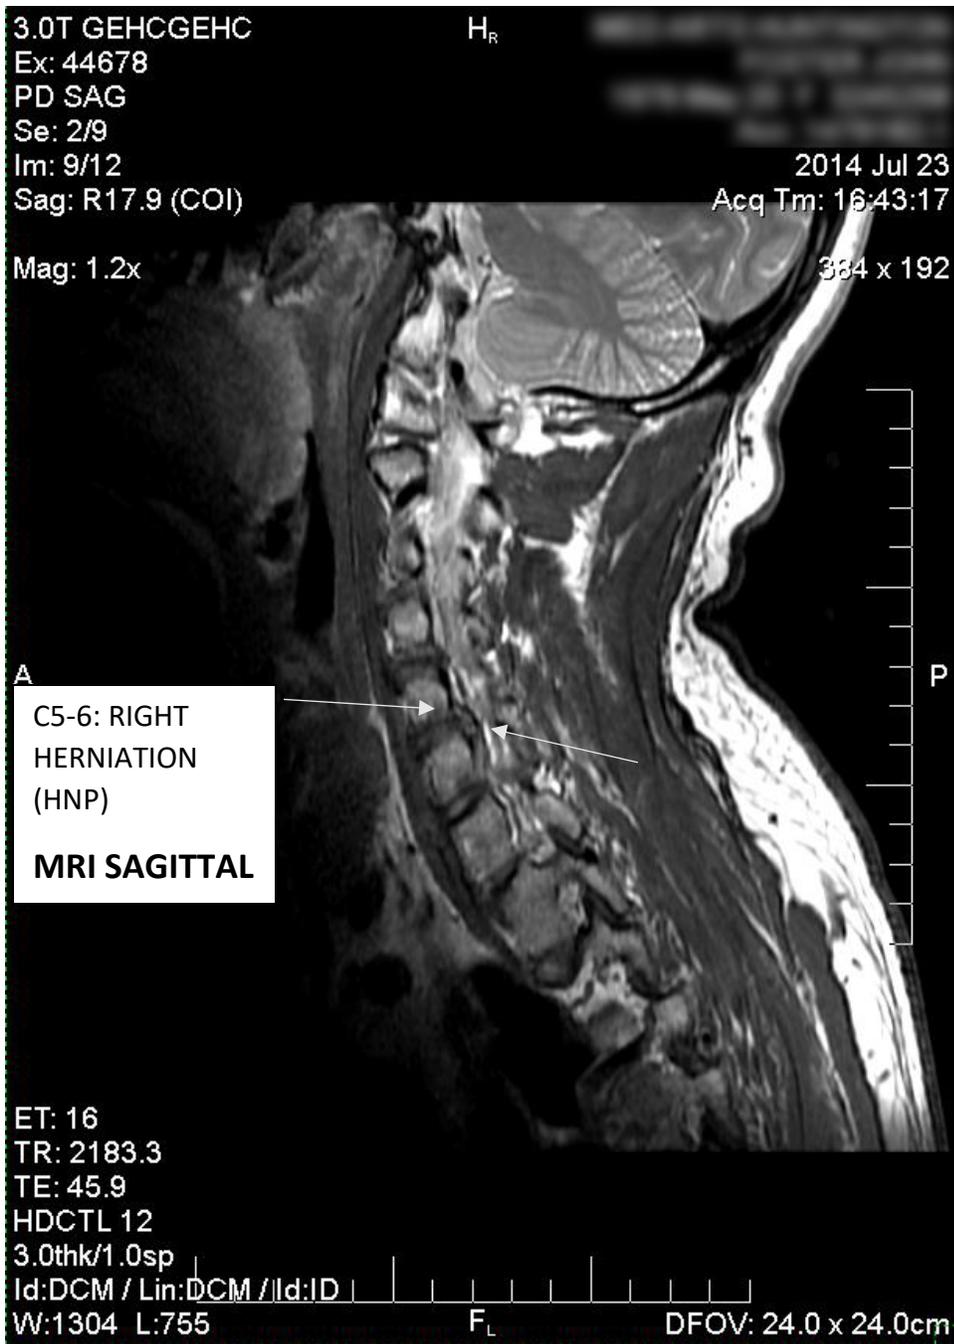
Figure 8

RIGHT SAGITTAL MRI, pre-op July 23 2014: There are no “covering” osteophytes to “support the herniation” above or below it. The signal of the herniation is similar to that of normal disk signal. This signal is due to water contained in the herniation. Old herniations dehydrate, loss water and become darker. The MRI signal comes from the hydrogen in water and tissues. Dehydration of a herniated disk takes many months to years to occur.

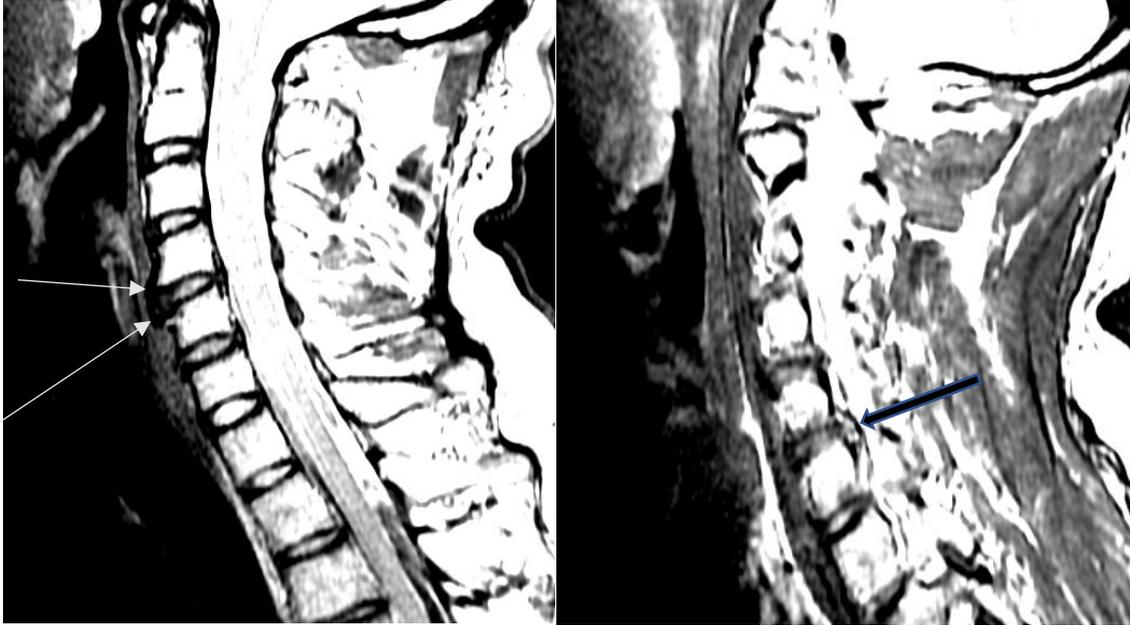
Figure 9 a, b: the images brightness level has been increased and contrast level has been reduced to better show differences in intensity. Both images are the same in brightness and contrast.

Fig. 9a: The anterior herniation at C4-5 is very dark because it is chronic, old, dehydrated, white arrows.

Fig. 9b: C5-6 the right posterior and foraminal herniation is bright and similar in intensity to normal disc material in between the vertebra indicating it is acute to subacute, recent, younger, black arrow.

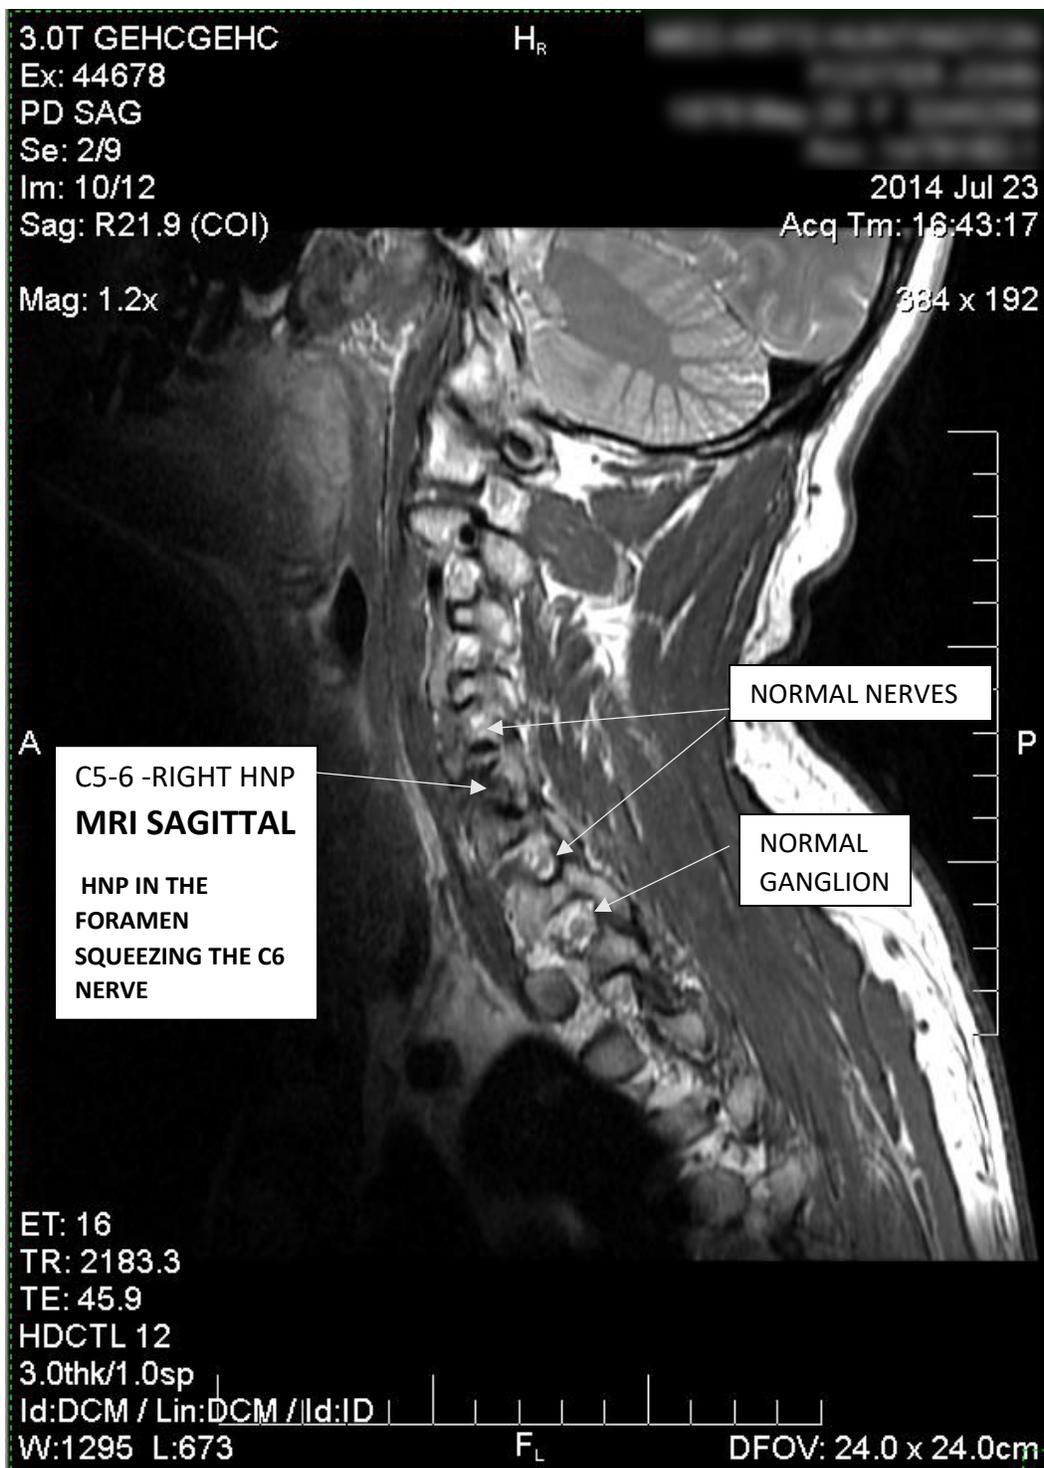
Figure 10

PRE-OP FURTHER RIGHT SAGITTAL MRI AT THE LEVEL OF THE FORAMEN, July 23, 2014: the herniation compresses the right C6 nerve exiting into the foramen. There is no osteophyte present in the foramen.

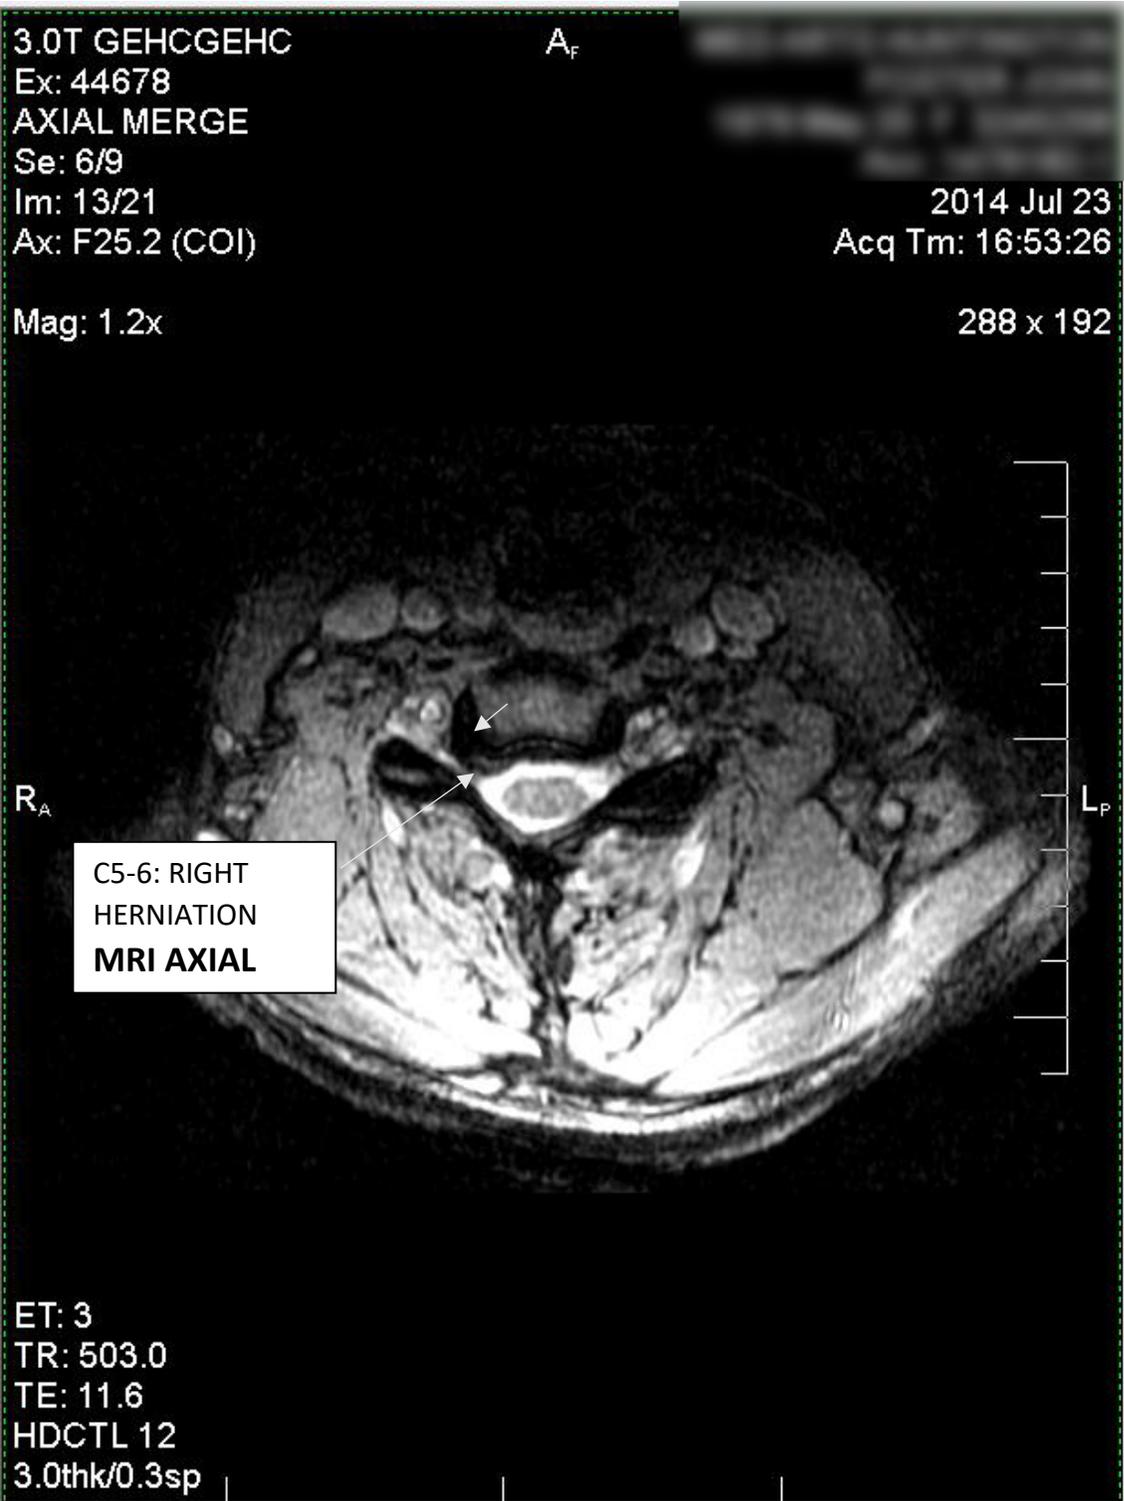
Figure 11

PRE-OP, AXIAL MRI SEQUENCE, this particular imaging sequence reduces the intensity of all tissues, July 23,2014: also shows increase signal in the herniated disk, arrow, indicating that it is not old, better seen in figure 9b.
